Limited Asbestos Survey Report

1. 1st and 2nd Floors – Central rooms of the North wing
(Areas impacted by water intrusion event)

- 2.1.1 Construction Type – Slab on grade, brick veneer
- 2.1.2 Building Type – School

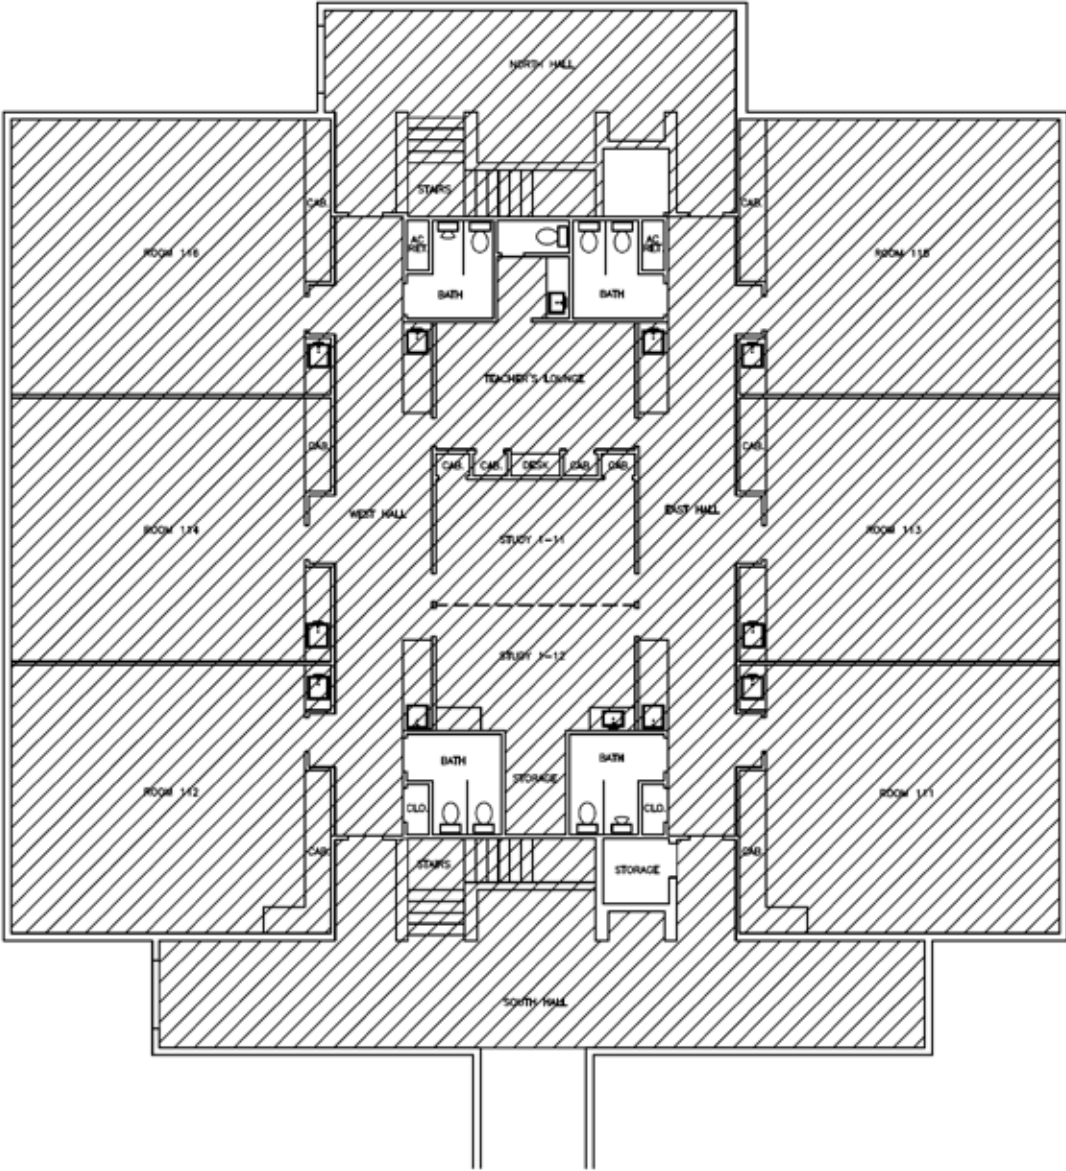
3.2 Sample Locations Diagrams
3.2.1 ACBM Floor Tile Diagram 1st Floor

ASBESTOS CONTAINING FLOOR TILE MASTIC

- Sample #1-7 - **Approximately 12,000 square feet of Green Floor Tile** (<1% Chrysotile asbestos) **and Black Mastic** (5% Chrysotile asbestos) located in the First and Second Floors.

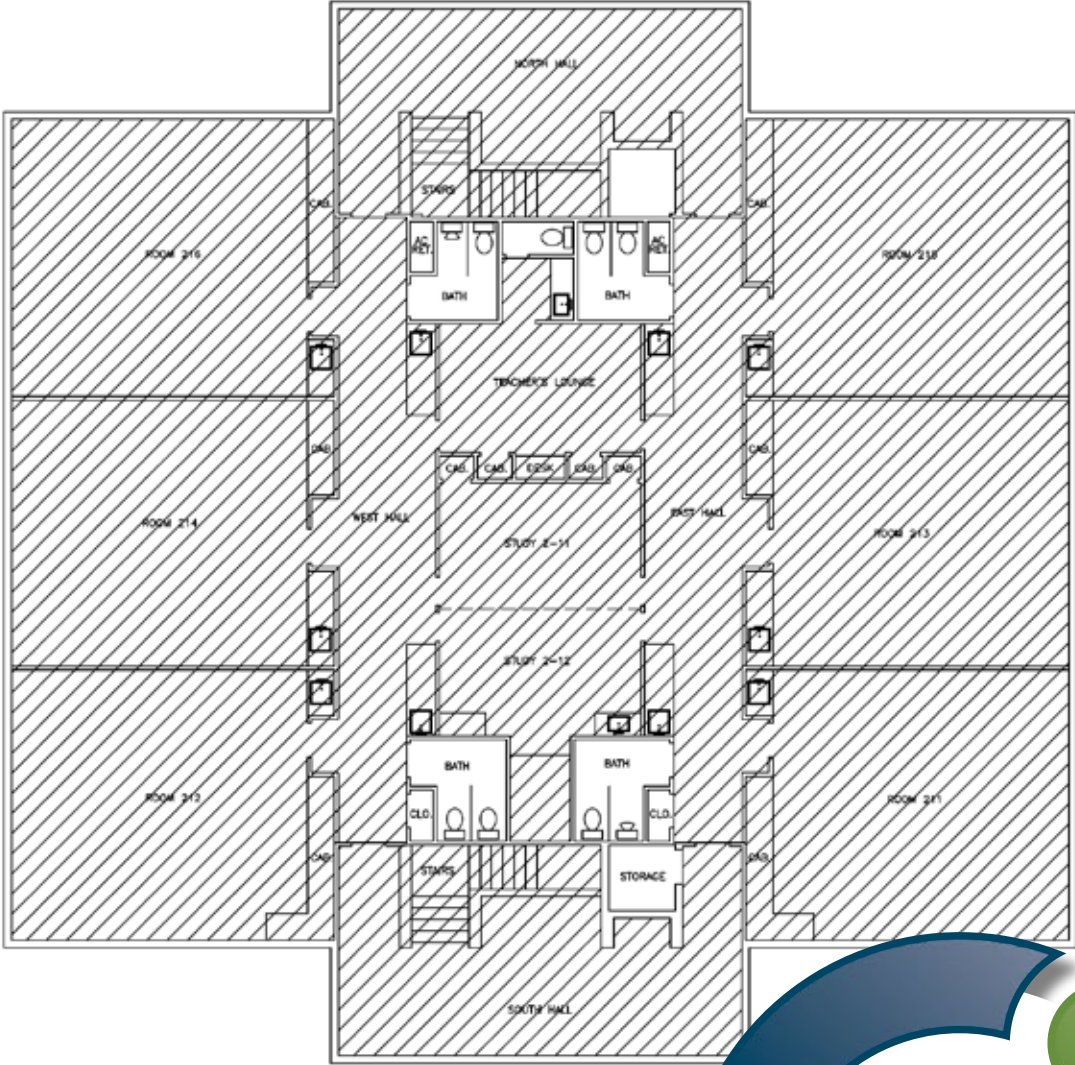
3.2.2 ACBM Floor Tile Diagram 2nd Floor

ASBESTOS CONTAINING FLOOR TILE MASTIC

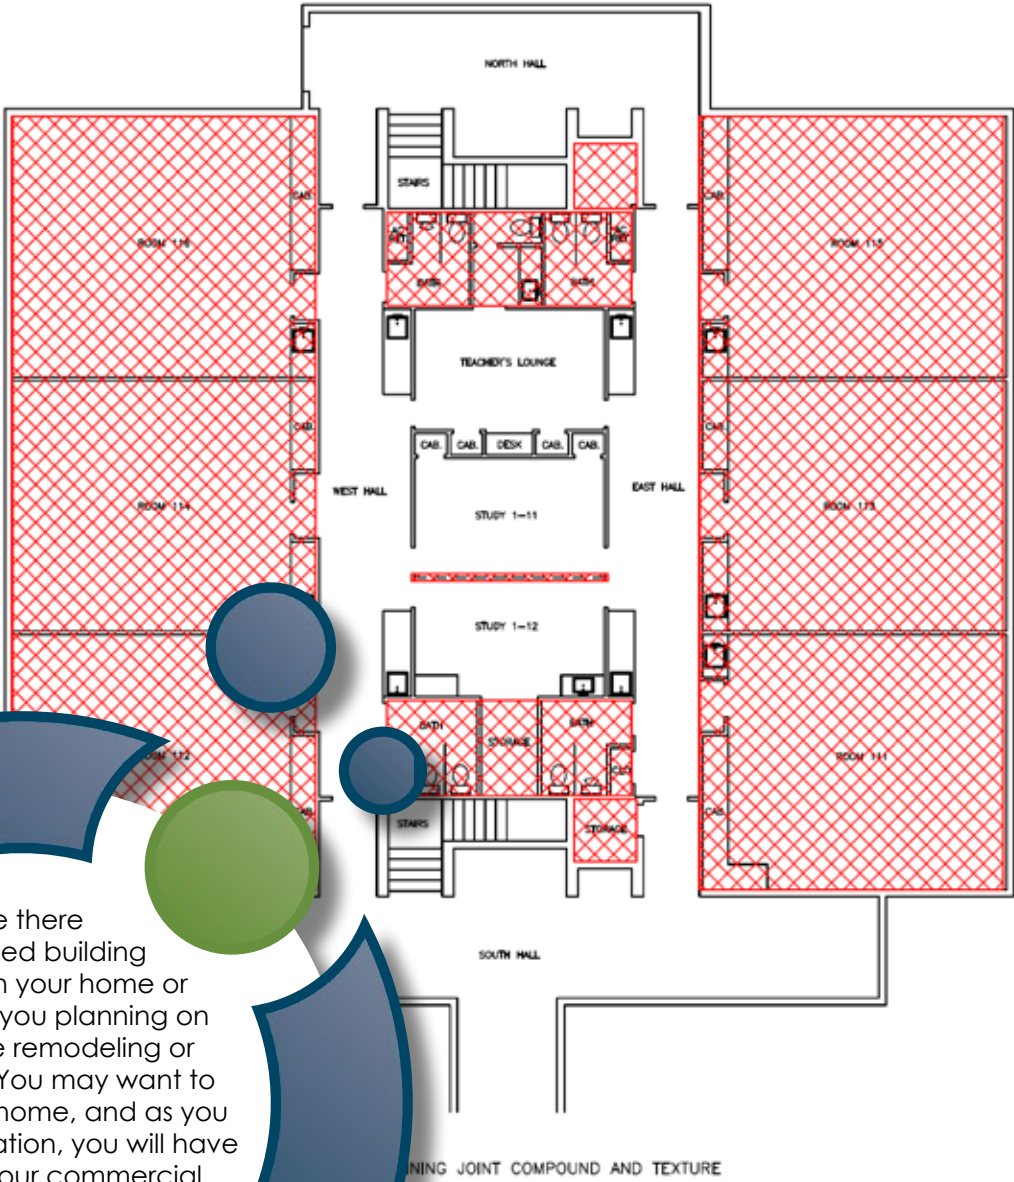
3.2.3 ACBM Joint Compound and Texture Diagram 1st Floor

- Sample #53-55, 65 and 66 - **Approximately 10,000 square feet of Texture/Paint** (2% Chrysotile asbestos) **and Joint Compound** (2% Chrysotile asbestos) located at wall materials in the 1st and 2nd Floor Bathrooms, Classrooms at fur downs and walls, common wall at Study 1-11/Study 1-12 and Study 2-11/Study 2-12, Ceiling at South Hallway, and Storage Rooms on 1st and 2nd Floors.

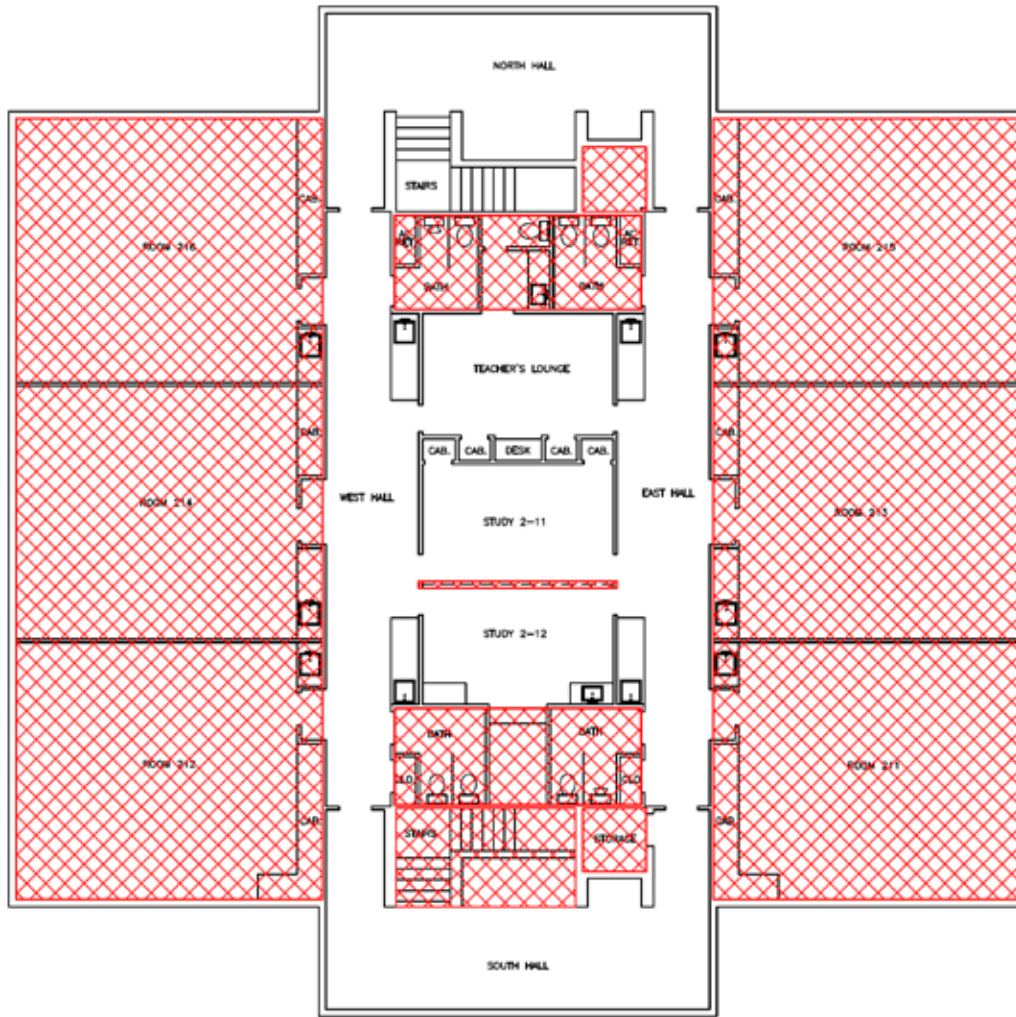
3.2.4 ACBM Joint Compound and Texture Diagram 2nd Floor

ASBESTOS CONTAINING JOINT COMPOUND AND TEXTURE

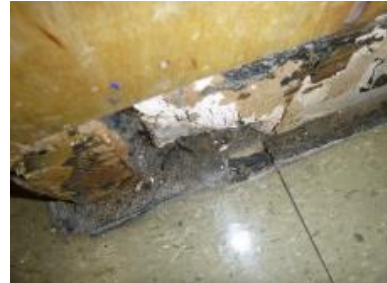
Sample #2

The asbestos-containing **Green Floor Tile** and **Black Mastic** identified were determined to be non-friable and in good condition with a “low” potential for disturbance.

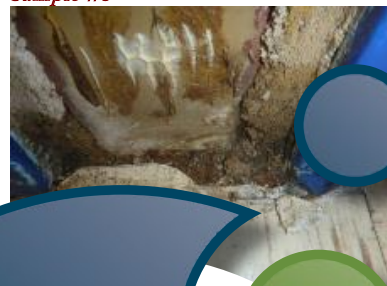
Sample #9

- Sample #8-10 - **Approximately 500 square feet of Black Mastic** (under Tan Stripe Floor Tile) (5% Chrysotile asbestos) located in Study 1-12, 1-11, and 1st Floor East Hallway.

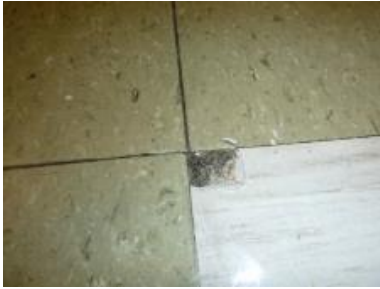
Sample #12

- Sample #11-13 - **Approximately 25 square feet of Black Mastic** (under White Stripe Floor Tile) (5% Chrysotile asbestos) located in 1st Floor West Hallway.

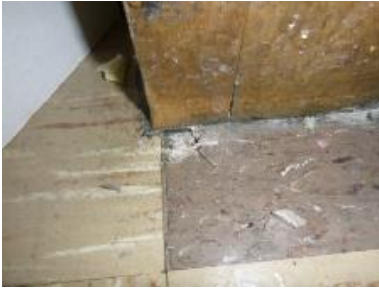
- Sample #24 and 25 - **Approximately 40 square feet of Black Mastic** (under Dark Brown Floor Tile) (5% Chrysotile asbestos) located in 1st Floor West Hallway.

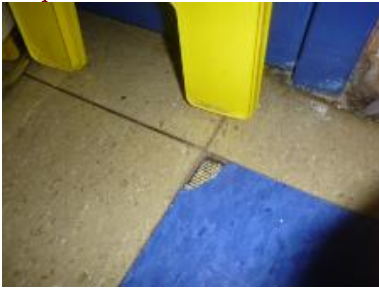
- Sample #27 - **Approximately 1 square foot of Black Mastic** (under Blue Floor Tile) (2% Chrysotile asbestos) located in 1st Floor West Hallway.
- Sample #34 - **Approximately 60 square feet of Black Mastic** (under Dark Brown Stripe Floor Tile) (5% Chrysotile asbestos) located in 2nd Floor North Hallway.

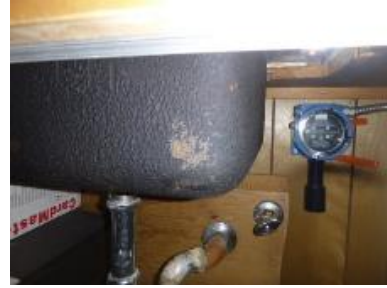
Sample #56

- Sample #56-58 - **Approximately 50 square feet of Black Sink Undercoating** (3% Chrysotile asbestos) located at the sinks in the 1st and 2nd Floor Hallways.

The asbestos-containing **Black Sink Undercoating** and **Gray Sink Coating** identified were determined to be non-friable and in good condition with a “low” potential for disturbance.

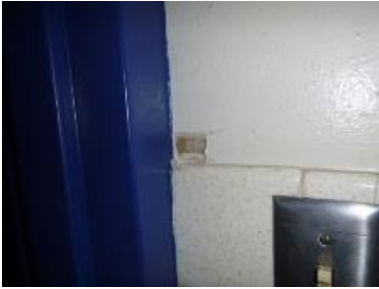
Sample #54

The asbestos-containing **Joint Compound** and **Texture** identified in the 1st and 2nd Floor Bathrooms were determined to be non-friable and in good condition with a “moderate” potential for disturbance.

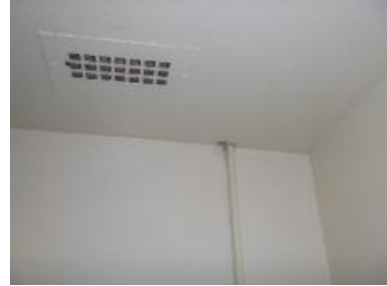
Sample #63

- Sample #62-64 - **Approximately 500 square feet of Texture/Paint** (2% Chrysotile asbestos) **and Joint Compound** (2% Chrysotile asbestos) located at ceiling materials in the 1st and 2nd Floor Bathrooms.
