Mold Inspection Sciences

MOLD INSPECTION AND TESTING REPORT

CLIENT	Sample Client
PROPERTY ADDRESS	1234 Mold Inspection Lane
DATE OF INSPECTION	Thursday, May 17, 2018

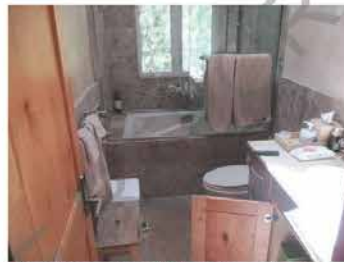
HALL BATHROOM [South Side]

Client stated previous water intrusion affected this area.

The client reported that the water loss that affected the Basement SE Room originated from the tub area while it was in use.

Moisture Content: Dry
Humidity - this area: 25%
Humidity - Outdoor: 26%
Suspected source(s) of water intrusion: Previous tub overflow
