Mold Inspection Report

Prepared for Sample Client
Date of Inspection - Wednesday, June 20, 2018

Section 1: Mold Inspection Information

Construction Type – Slab on grade, siding and rock veneer, composition roof, and drywall interior finish
Building Type – Single Family Home
Size – 3,000 square feet
Scope – Entire Home

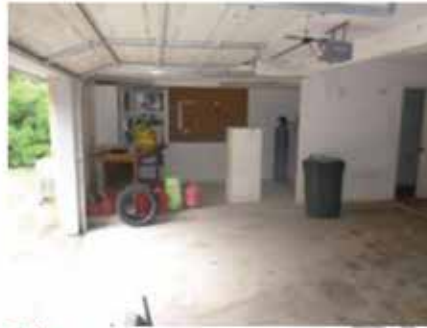
Mold-like growth was observed in this area.

Moisture Content: Dry

Area affected: ~50 SF

Suspected source(s)/
cause(s): Leak in
Bathroom above

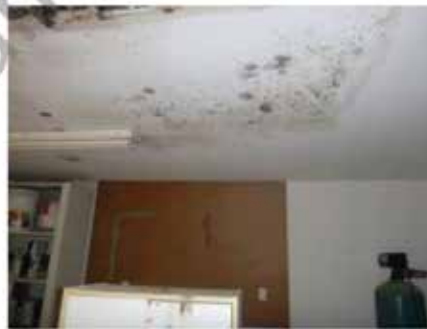
GARAGE [MS-2]

Water damage was observed in this area.

This condition may indicate a moisture intrusion problem. Moisture can lead to microbial growth.

Moisture Content: Dry

Area affected: ~50 SF

Suspected source(s)/
cause(s): Leak in
Bathroom above

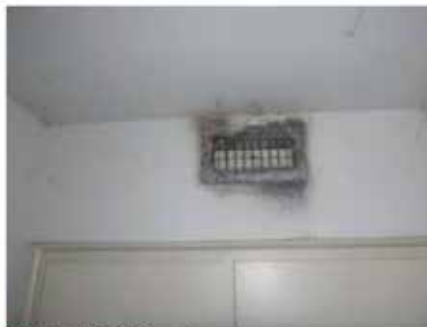
Wall at HVAC supply

Mold-like growth was observed in this area.

Moisture Content: Dry
Area affected: ~1 SF
Suspected source(s)/ cause(s): Condensation

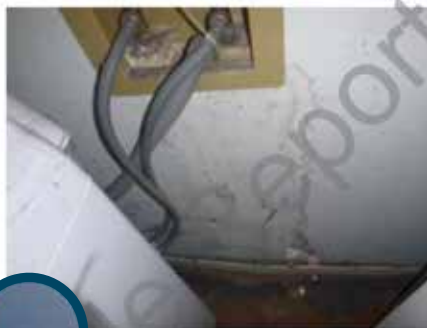
Behind washer

Water damage was observed in this area.

This condition may indicate a moisture intrusion problem. Moisture can lead to microbial growth.

Moisture Content: Suspect
Humidity - this area: 92%
Humidity - Outdoor: 96%
Area affected: ~10 SF
Suspected source(s)/ cause(s): Leak at washer
** Humidity level for this area is above the ASHRAE recommended level for habitable spaces. Preferable level is between 30% and 60%.*

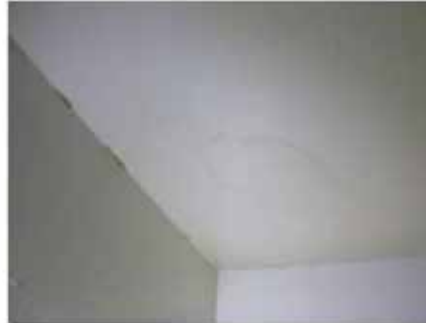
Staining was observed in this area.

This condition may indicate a moisture intrusion problem. Moisture can lead to microbial growth.

Moisture Content: **Wet**

Suspected source(s)/
cause(s): Roof leak

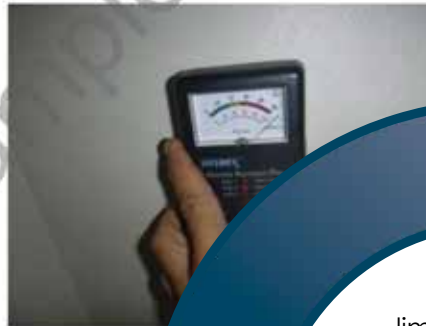
PANTRY [MS-6]

Ceiling materials tested in this area indicated high moisture content.

This condition is an indicator of a water intrusion issue.

Moisture Content: **Wet**

NOTICE: All wet materials should be dried out within 24-48 hours to prevent mold growth.

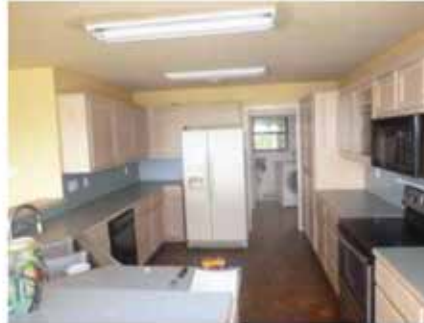
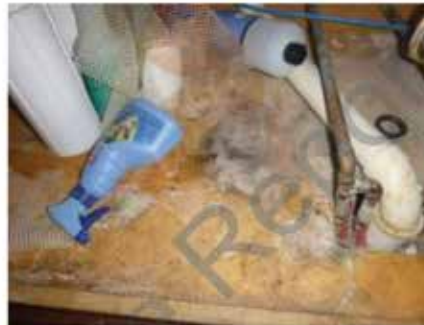
Moisture damage was present in the cabinet below the sink.

This condition can indicate a present or past moisture intrusion issue. Any time water has infiltrated walls or under cabinetry, hidden mold growth is possible.

Moisture Content: Dry

Suspected source(s)/ cause(s): Plumbing leak and/or spilled contents

Consider consulting a licensed professional for evaluation and repair.

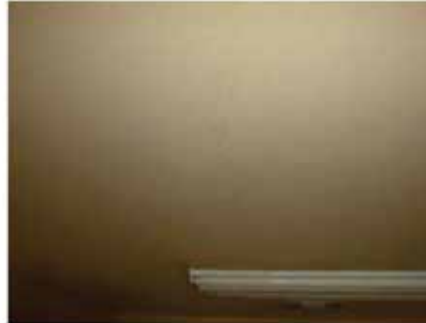
Staining was observed in this area.

This condition may indicate a moisture intrusion problem. Moisture can lead to microbial growth.

Moisture Content: **Dry**

Suspected source(s)/
cause(s): **Undetermined**

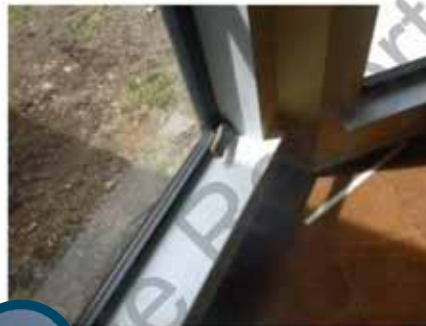
Water damage and wet materials observed on window sill.

This condition may be an indicator of a moisture problem, which may be due to deteriorated exterior window caulking or brick mortar. Moisture can lead to microbial growth.

Moisture Content: **Wet**

Suspected source(s)/
cause(s): **Water intrusion at window**

NOTICE: All wet materials should be dried out within 24-48 hours to prevent mold growth.

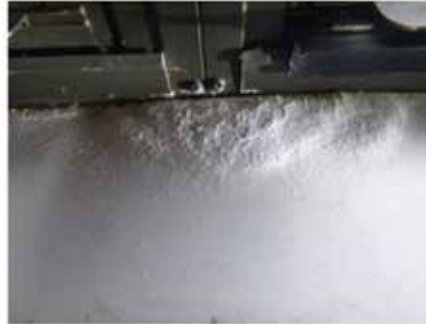
**DINING ROOM [East Side]
[MS-11]**

Water damage was observed on window sill.

This condition may indicate a moisture problem that could lead to microbial growth.

Moisture Content: **Wet**

Suspected source(s)/
cause(s): Water intrusion
at window

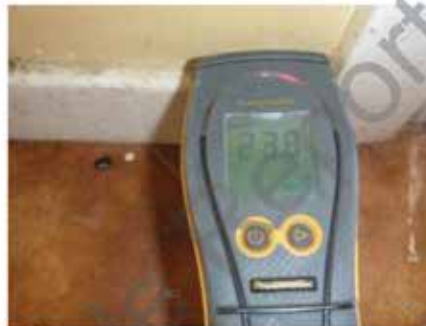
Wall materials tested in this area indicated high moisture content.

This condition is an indicator of a water intrusion issue.

Moisture Content: **Wet**

Suspected source(s)/
cause(s): Intrusion at
exterior door

NOTICE: All wet materials should be dried out within 24-48 hours to prevent mold growth.

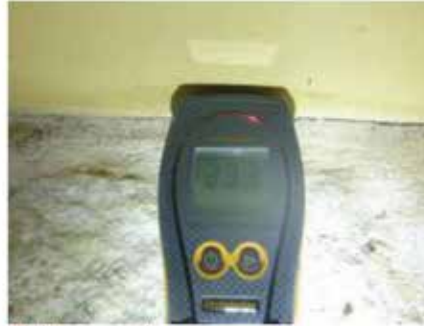
Wall below window

Wall materials tested in this area indicated high moisture content.

This condition is an indicator of a water intrusion issue.

Moisture Content: **Wet**

Suspected source(s)/ cause(s): Window leak

NOTICE: All wet materials should be dried out within 24-48 hours to prevent mold growth.

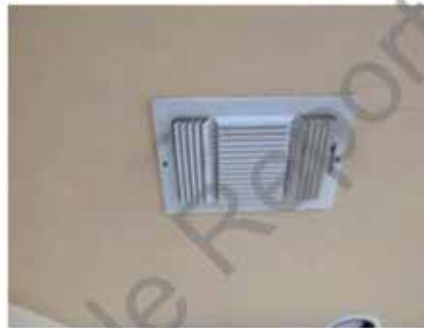
Staining was observed around the supply register(s).

This can indicate excessive condensation in the HVAC system. Moisture can create an environment conducive to microbial growth.

Moisture Content: **Dry**

Suspected source(s)/ cause(s): Condensation

Consider contacting a licensed HVAC professional for evaluation and repair.

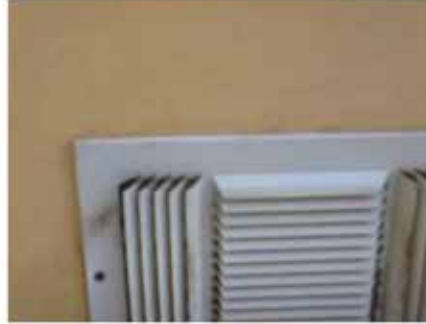
Dust build-up and suspect mold growth were observed on HVAC supply vents and on the surrounding ceiling material.

Moisture Content: Dry

Suspected source(s)/ cause(s): Condensation

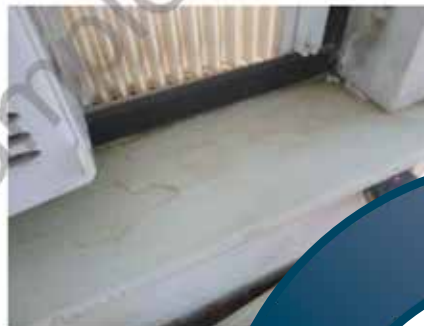
MASTER BEDROOM
[South Side] [MS-23]

Window sill tested for moisture indicated elevated moisture content.

This condition may be an indicator of a moisture problem, which may be due to deteriorated exterior window caulking or brick mortar. Moisture can lead to microbial growth.

Moisture Content: Suspect

NOTICE: All wet materials should be dried out within 24-48 hours to prevent mold growth.

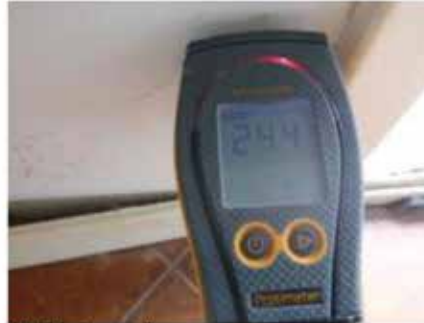
Wall below window

Wall materials tested in this area indicated high moisture content.

This condition is an indicator of a water intrusion issue.

Moisture Content: **Wet**

Suspected source(s)/ cause(s): Leak at window

NOTICE: All wet materials should be dried out within 24-48 hours to prevent mold growth.

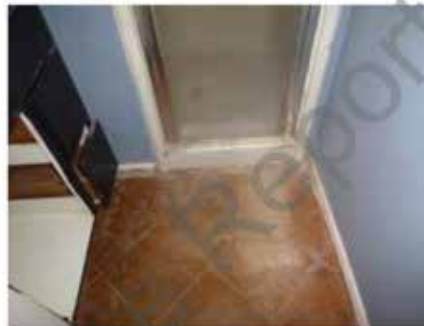
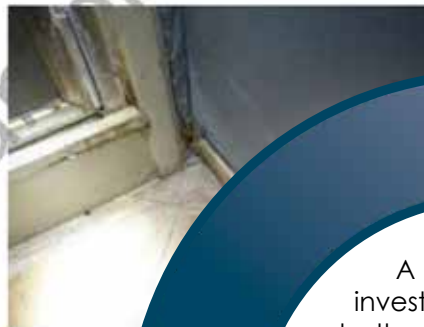
Water damage and wet wall materials were observed at the base of the wall next to the shower.

These conditions are indicators of a plumbing leak and/or other moisture issue.

Moisture Content: **Suspect**

Suspected source(s)/ cause(s): Leak at shower

NOTICE: All wet materials should be dried out within 24-48 hours to prevent mold growth.

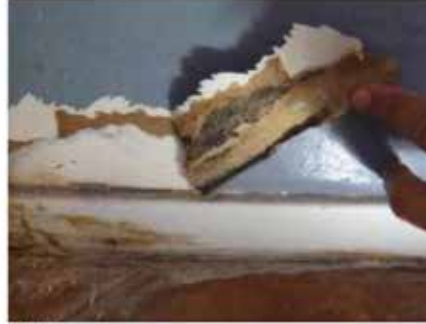
Wall

Mold-like growth was observed in this area.

Moisture Content: Suspect

Suspected source(s)/
cause(s): Leak at shower

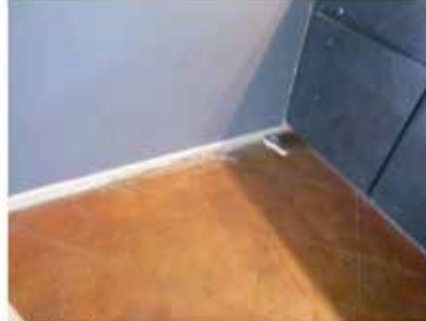
Baseboard

Water damage was observed in this area.

This condition may indicate a moisture intrusion problem. Moisture can lead to microbial growth.

Moisture Content: **Dry**

Suspected source(s)/ cause(s): Leak at shower

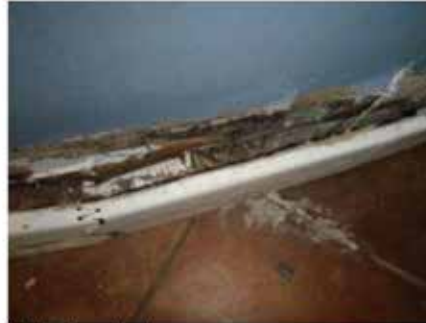
Behind baseboard

Mold-like growth was observed in this area.

Moisture Content: **Wet**

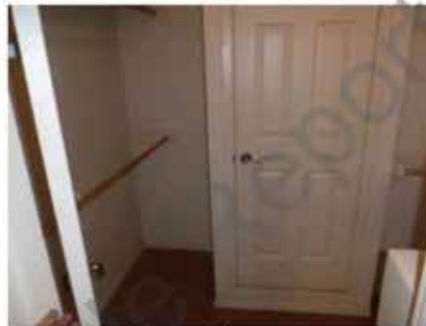
Baseboard and lower wall

Moisture Content: **Dry**

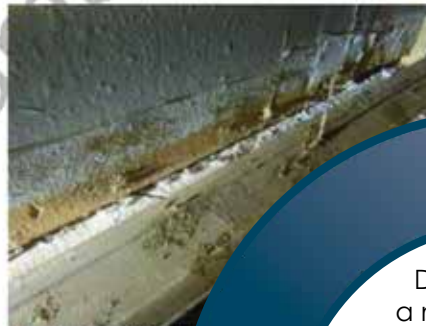
Baseboard and lower wall

Moisture Content: **Dry**

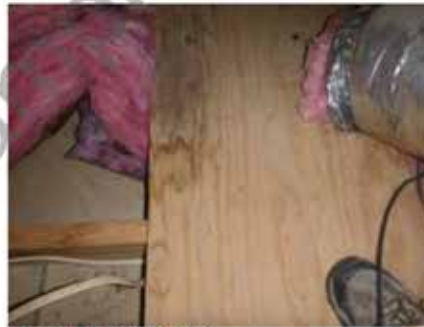
Decking at HVAC unit

Staining was observed in this area.

This condition may indicate a moisture intrusion problem. Moisture can lead to microbial growth.

Moisture Content: Dry

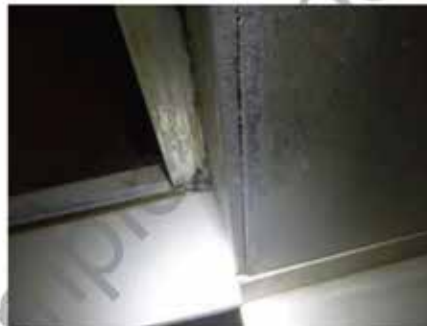
ATTIC / HVAC [PM-3]

The HVAC air handler appears to be in poor condition.

This issue was noted for preventative maintenance purposes. Consider consulting a licensed contractor for evaluation and correction or repair.
