## Mold Inspection Report

123 Main St ~ Hometown, TX 71032

Prepared for Penny Smith  
Date of Inspection - Friday, October 31

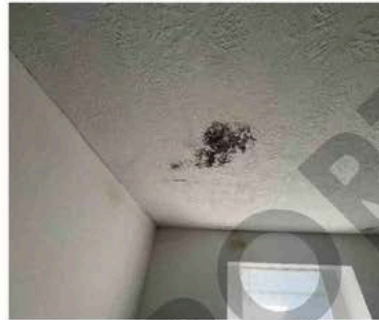
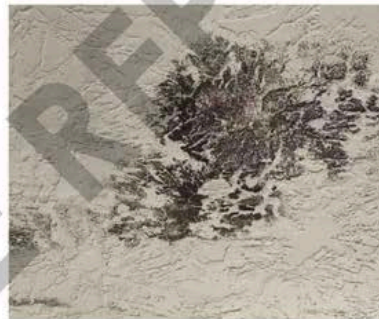
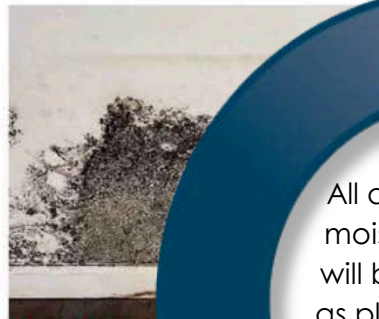
#### DINING ROOM

| Room/Area | Location within Room/Area and/or Affected Materials |
|---|---|
| Dining Room | Mold Impacted and Water Damaged Materials. The air sample collected showed suspect airborne mold spore counts and mold growth was confirmed at the Ceiling / Wall Sheetrock. Additional hidden mold growth is possible within the ceiling plenum and/or within the wall cavities. |

| Lab Code | Location | Conclusion | Comments |
|---|---|---|---|
| DE01 | Dining Room (Ceiling/wall Sheetrock) | <b>Mold Growth: Chaetomium species Penicillium/Aspergillus group</b> | Recommended by inspector and approved by client |

Suspect mold growth was observed in this area.

Moisture Content: Dry  
Humidity this area: 52%  
Humidity Outdoor: 40%  
Area Affected: 100 SF  
Suspected source(s)/cause(s):  
Humidity / condensation due to utilities off for a year

*Mold-like growth on drywall on both sides of this area.*

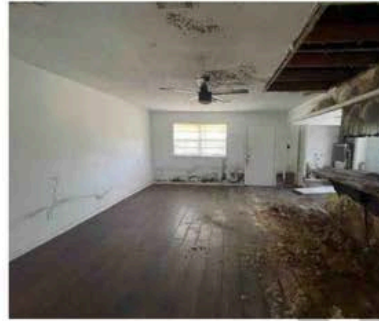
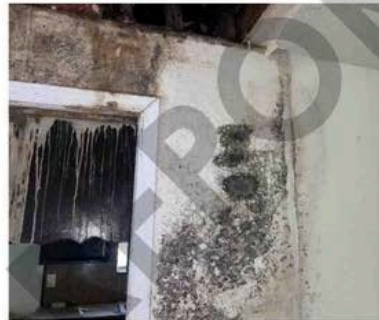
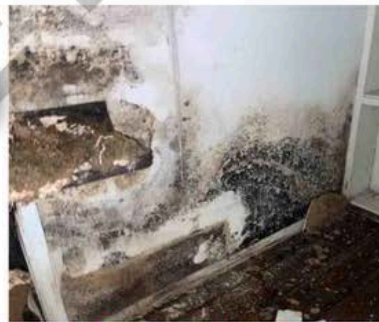
## LIVING ROOM

| Room/Area | Location within Room/Area and/or Affected Materials |
|---|---|
| Living Room | Mold Impacted and Water Damaged Materials. The air sample collected showed elevated airborne mold spore counts and mold growth was confirmed at the Ceiling and Wall Sheetrock / Ceiling, Framing Members. Additional hidden mold growth is possible within the ceiling plenum, within the wall cavities and/or in association with the flooring materials. |

Suspect mold growth was observed in this area.

Moisture Content: Dry

Humidity this area: 53%

Area Affected: 600 SF

Suspected  
source(s)/cause(s):  
Leak from attic and  
Humidity / condensation  
due to utilities off for a  
year

*Mold-like growth was observed on the ceiling and wall drywall in this area.*

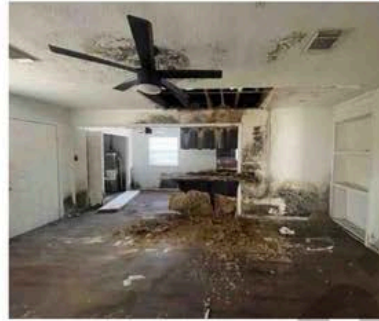
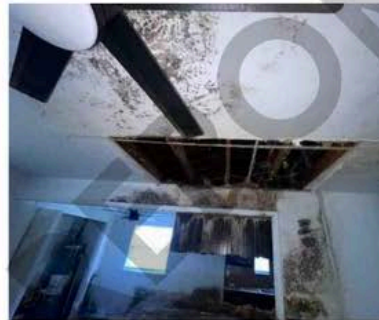
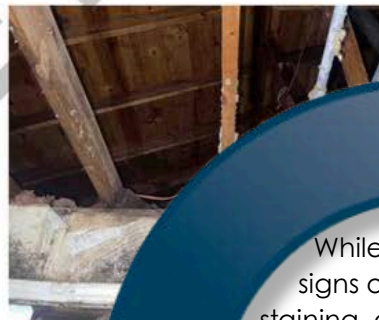
### LIVING ROOM

Staining or visible signs of water damage was/were observed in this area.

Moisture Content: Dry

Area Affected: 300 SF

Suspected  
source(s)/cause(s):  
Burst water supply line in  
Attic

There were  
damage to

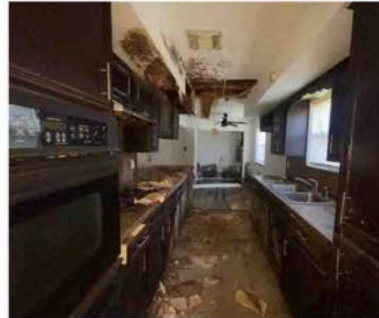
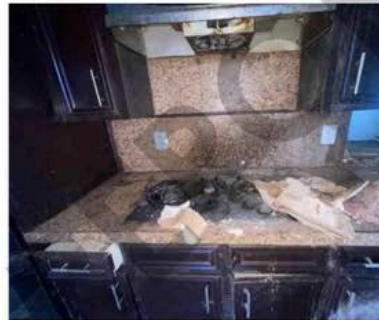
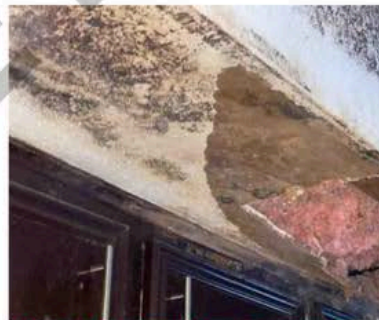
## KITCHEN

| Room/Area | Location within Room/Area and/or Affected Materials |
|---|---|
| Kitchen | Mold Impacted and Water Damaged Materials. The air sample collected showed elevated airborne mold spore counts and mold growth was confirmed at the Ceiling and Wall Sheetrock. Additional hidden mold growth is possible within the ceiling plenum, under/around the cabinetry, within the wall cavities and/or in association with the flooring materials. |

Suspect mold growth was observed in this area.

Moisture Content: Dry

Humidity this area: 55%

Area Affected: 500 SF

Suspected  
source(s)/cause(s):  
Burst water supply line in  
Attic

*Mold - Lake growth was observed on the ceiling and wall sheetrock.*

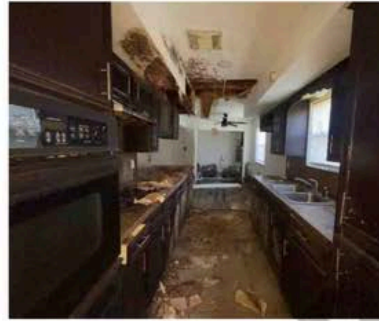
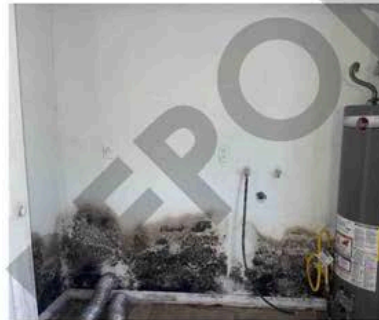
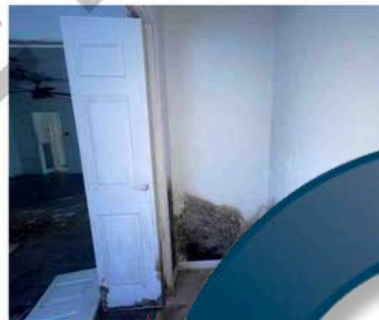
#### UTILITY CLOSET

| Room/Area | Location within Room/Area and/or Affected Materials |
|---|---|
| Utility Closet | Mold Impacted and Water Damaged Materials. The air sample collected showed elevated airborne mold spore counts and mold growth was confirmed at the Ceiling and Drywall Sheetrock and Wall. Additional hidden mold growth is possible within the ceiling plenum, within the wall cavities and/or in association with the flooring materials. |

| DE06 | Utility Closet (Ceiling and Drywall Sheetrock and Trim/Flooring) | <b>Mold Growth: Stachybotrys species<br/>Aspergillus species Chaetomium species</b> | Recommended by inspector and approved by client |

Suspect mold growth was observed in this area.

Moisture Content: Dry

Humidity this area: 55%

Area Affected: 120 SF

Suspected  
source(s)/cause(s):  
Humidity / condensation  
due to utilities off for a  
year

*Mold-like growth  
flooring and dryw*

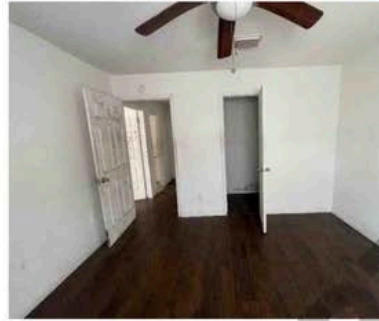
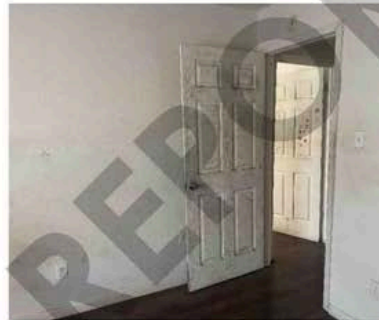
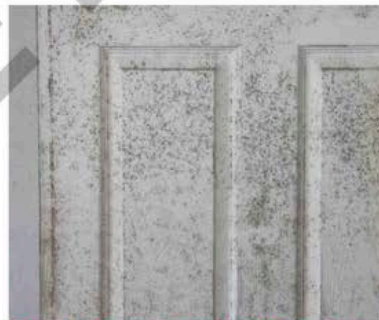
### NORTHEAST BEDROOM

| Room/Area | Location within Room/Area and/or Affected Materials |
|---|---|
| Northeast Bedroom | Mold Impacted and Water Damaged Materials. The air sample collected showed elevated airborne mold spore counts and mold growth was confirmed at the Ceiling and Wall Sheetrock / Door. Additional hidden mold growth is possible within the ceiling plenum and/or within the wall cavities. |

| DE08 | Northeast Bedroom (Ceiling and Wall Sheetrock/Door and Door Trim) | <b>Mold Growth: Aspergillus species</b> | Recommended by inspector and approved by client |

Suspect mold growth was observed in this area.

Moisture Content: Dry

Humidity this area: 48%

Area Affected: 200 SF

Suspected  
source(s)/cause(s):  
Humidity / condensation  
due to utilities off for a  
year

*Mold-like growth was observed on the  
ceiling and wall drywall, and also the  
doors and trim.*

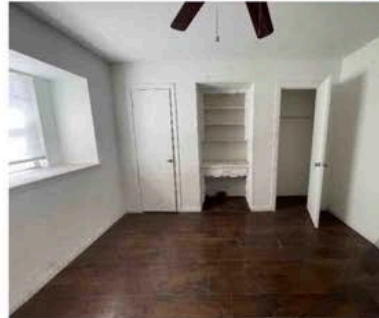
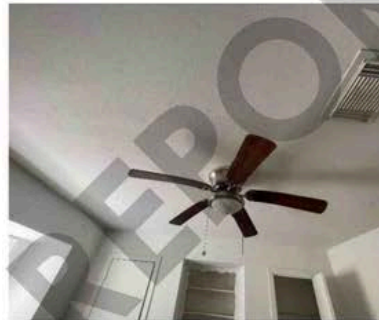
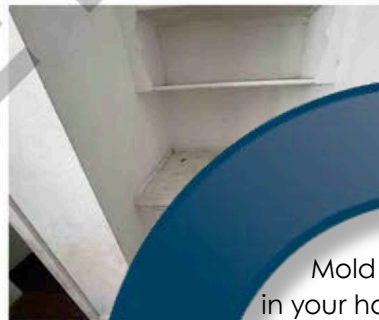
### SOUTHEAST BEDROOM

| Room/Area | Location within Room/Area and/or Affected Materials |
|---|---|
| Southeast Bedroom | Mold Impacted and Water Damaged Materials. The air sample collected showed elevated airborne mold spore counts and mold growth was confirmed at the Ceiling and Wall Sheetrock. Additional hidden mold growth is possible within the ceiling plenum and/or within the wall cavities. |

| DE09 | Southeast Bedroom (Ceiling and Wall Drywall/Doors and Cabinetry Material) | <b>Mold Growth: Aspergillus species</b> | |

Suspect mold growth was observed in this area.

Moisture Content: Dry

Humidity this area: 48%

Area Affected: 200

Suspected  
source(s)/cause(s):  
Humidity / condensation  
due to utilities off for a  
year

Mold-like  
ceiling and  
desk in the

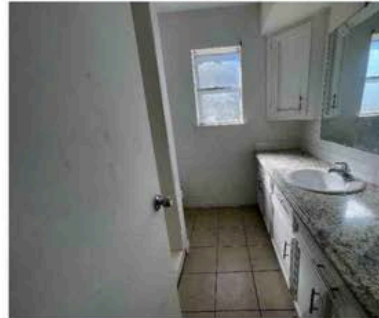
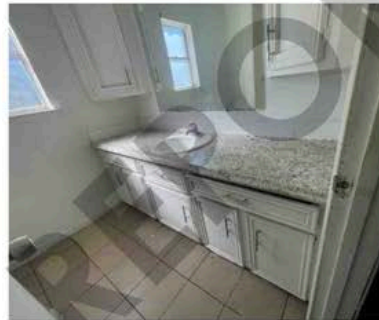
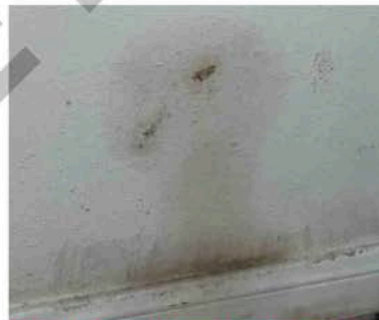
### HALL BATHROOM

| Hall Bathroom | Mold Impacted and Water Damaged Materials. The air sample collected showed elevated airborne mold spore counts and mold growth was confirmed at the Ceiling and Wall Sheetrock / Cabinetry / Tile. Additional hidden mold growth is possible within the ceiling plenum, within the wall cavities, under/around the cabinetry and/or in association with the flooring materials. |

Suspect mold growth was observed in this area.

Moisture Content: Dry

Humidity this area: 48%

Area Affected: 300 SF

Suspected  
source(s)/cause(s):  
Humidity / condensation  
due to utilities off for a  
year

*Mold-like growth was observed on the drywall, and the cabinetry.*

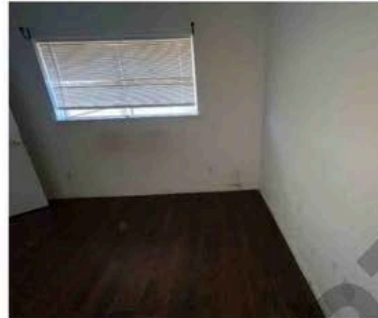
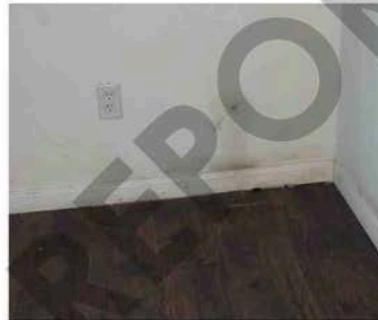
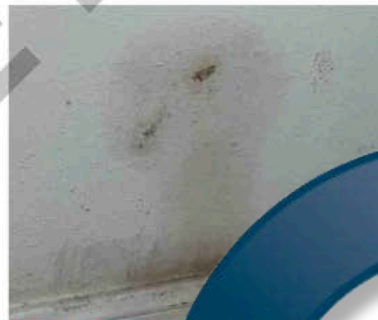
**PRIMARY BEDROOM**

| Primary Bedroom | Mold Impacted and Water Damaged Materials. The air sample collected showed elevated airborne mold spore counts and mold growth was confirmed at the Ceiling and Wall, Drywall, Tile. Additional hidden mold growth is possible within the ceiling plenum, within the wall cavities and/or in association with the flooring materials. |

| DE11 | Primary<br>Bedroom<br>(Ceiling<br>and Wall,<br>Drywall,<br>Tile) | <b>Mold Growth: Aspergillus species</b> | Recommended by inspector and<br>approved by client |

Suspect mold growth was observed in this area.

Moisture Content: Dry

Humidity this area: 48%

Area Affected: 200 SF

Suspected  
source(s)/cause(s):  
Humidity / condensation  
due to utilities off for a  
year

*Mold-like growth  
wall and ceiling  
ceiling fan.*

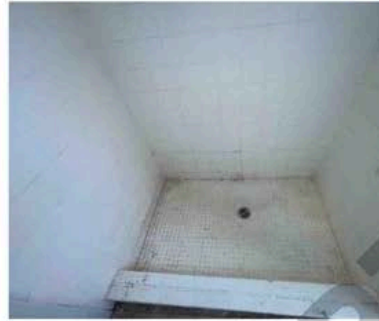
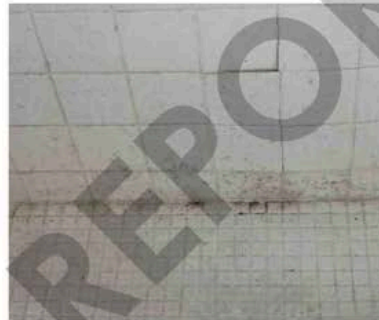
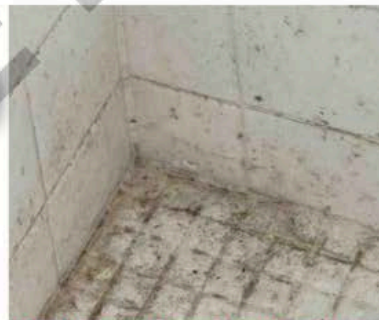
### PRIMARY BATHROOM

| Primary Bathroom | Mold Impacted and Water Damaged Materials. The air sample collected showed elevated airborne mold spore counts and mold growth was confirmed at the Ceiling and Wall Sheetrock / Tile / Cabinetry. Additional hidden mold growth is possible within the ceiling plenum, within the wall cavities, under/around the cabinetry and/or in association with the flooring materials. |

| DE12 | Primary<br>Bathroom<br>(Ceiling<br>and Wall<br>Sheetrock/<br>Tile/<br>Cabinetry) | <b>Mold Growth:<br/>Penicillium/Aspergillus group</b> | Recommended by inspector and<br>approved by client |

**Suspect mold growth was observed in this area.**

Moisture Content: **Dry**

Humidity this area: **48%**

Area Affected: **600 SF**

Suspected  
source(s)/cause(s):  
**Humidity / condensation  
due to utilities off for a  
year**

*Mold-like growth was observed in the  
tile, shower, surround, the cabinetry,  
and on the ceiling and wall drywall.*

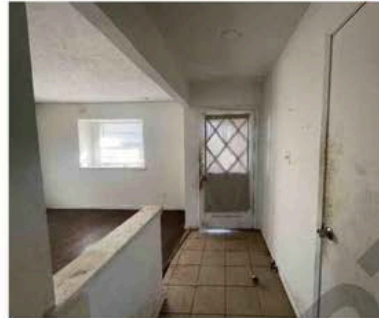
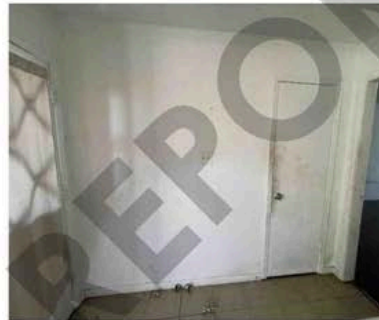
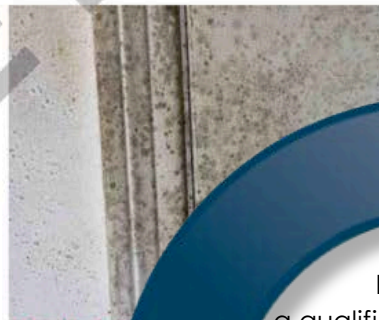
**ENTRY**

| Room/Area | Location within Room/Area and/or Affected Materials |
|---|---|
| Entry | Mold Impacted and Water Damaged Materials. The air sample collected showed elevated airborne mold spore counts and mold growth was confirmed at the Entry and Hall Closet Doors, Ceiling, and Wall, Drywall, Flooring. Additional hidden mold growth is possible within the ceiling plenum, within the wall cavities and/or in association with the flooring materials. |

Suspect mold growth was observed in this area.

Moisture Content: Dry

Humidity this area: 54%  
Humidity Outdoor: 40%

Area Affected: 300 SF

Suspected  
source(s)/cause(s):  
Humidity / condensation  
due to utilities off for a  
year

Mold-like growth  
entry and on  
the ceiling

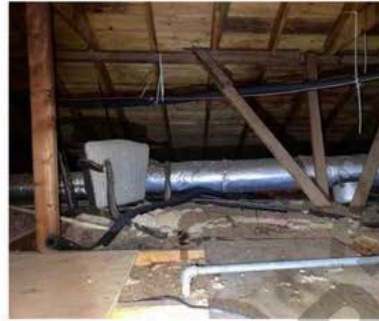
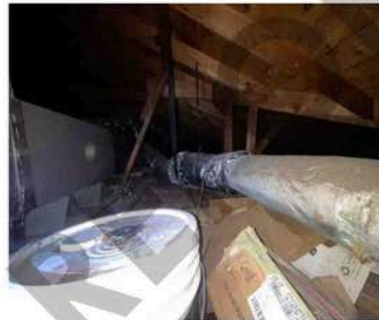
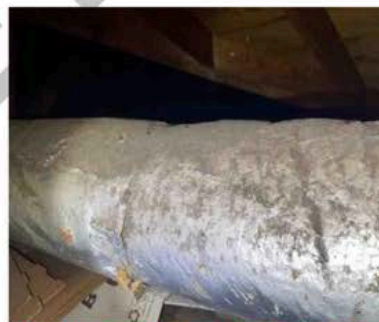
## ATTIC

| Attic | Mold Impacted and Water Damaged Materials. Mold growth was confirmed at the HVAC Air Handler Cabinet and Ductwork. Additional hidden mold growth is possible in association with the HVAC system and components. |

| DE07 | Attic (HVAC Air Handler Cabinet and Ductwork) | <b>Mold Growth: Cladosporium species Penicillium/Aspergillus group Stachybotrys species</b> | Recommended by inspector and approved by client |

Suspect mold growth was observed at the HVAC unit, on the ductwork and/or around the main supply plenum.

Moisture Content: Dry

Humidity this area: 55%

Area Affected: 200 SF

Suspected  
source(s)/cause(s):  
Severe roof damage

*Mold-like growth was observed on the ductwork, and on the air handler cabinet.*

... - Engage a licensed HVAC contractor to evaluate and repair the following items should be included:  
 - HVAC system(s) for proper functioning and airflow balancing.  
 - Cause of excessive condensation and/or high relative humidity  
 - Addressed with the system(s)

- Remove and replace mold impacted insulation from supply register boxes or replace the supply boxes.
- Check condition of interior of main supply plenum and replace if impacted.
- Clean, if possible, or replace mold impacted ductwork
- Clean or replace all mold impacted and/or rusty supply grills.
- Clean the return plenum(s) and replace all filters.

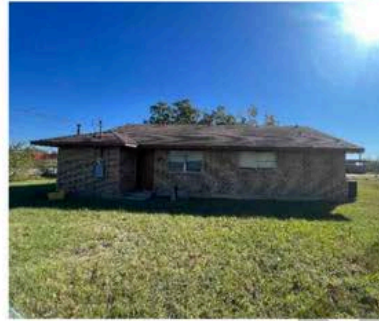
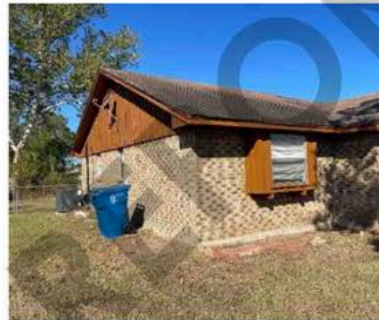
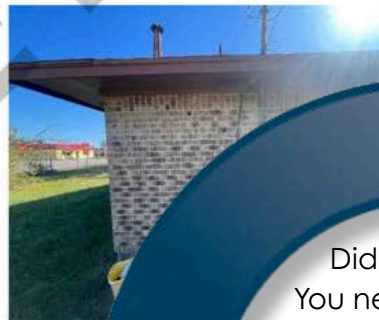
## EXTERIOR

The structure does not have rain gutters and/or gutters are missing from one or more appropriate locations.

Moisture Content: Dry  
Humidity Outdoor: 40%  
Area Affected: 60 LF  
Suspected  
source(s)/cause(s):  
Missing rain gutters

Rain gutters  
recommended

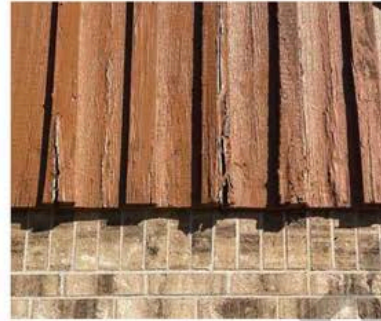
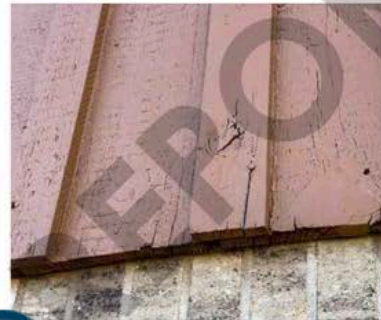
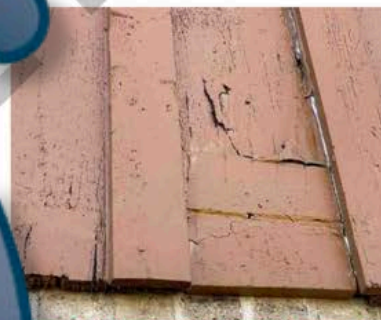
## EXTERIOR

**Wood decay present. This condition may be an indicator of a past or present moisture issue or possible insect infestation.**

Moisture Content: **Dry**

Area Affected: **30 SF**

Suspected source(s)/cause(s):  
**Deteriorated paint/sealant**

*Wood rot/decay was observed around the exterior of the home.*

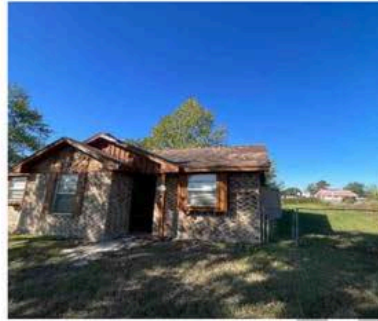
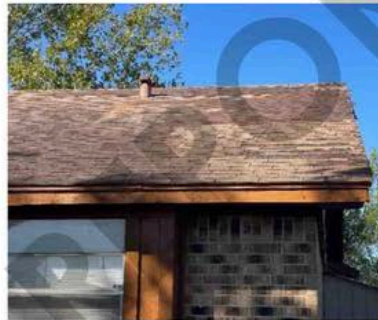
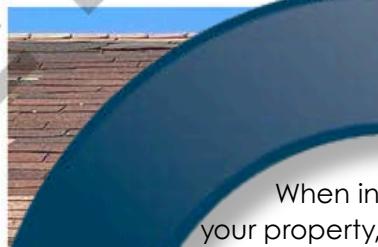
**EXTERIOR**

**Worn or damaged roofing materials, signs of ponding, or previous repairs were noted.**

Moisture Content: **Dry**  
Humidity Outdoor: **40%**  
Area Affected: **1200 SF**  
Suspected source(s)/cause(s):  
**Damaged roofing materials**
