Mold Inspection Report

Prepared for Sample Client
Date of Inspection - Wednesday, June 20, 2018

Section 1: Mold Inspection Information

Construction Type – Slab on grade, siding and rock veneer, composition roof, and drywall interior finish
Building Type – Single Family Home
Size – 3,000 square feet
Scope – Entire Home

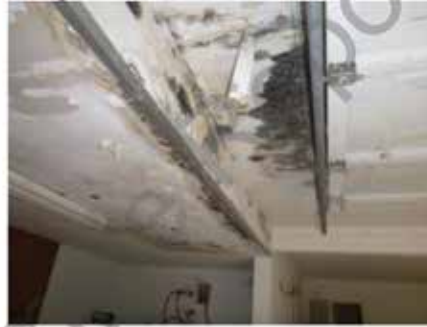
GARAGE [MS-2]

Water damage was observed in this area.

This condition may indicate a moisture intrusion problem. Moisture can lead to microbial growth.

Moisture Content: Dry

Suspected source(s)/
cause(s): Leak in
Bathroom above

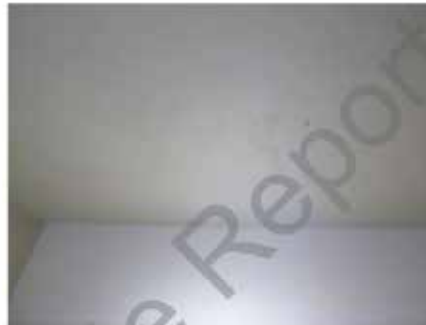
PANTRY [MS-6]

Ceiling materials tested in this area indicated high moisture content.

This condition is an indicator of a water intrusion issue.

Moisture Content: **Wet**

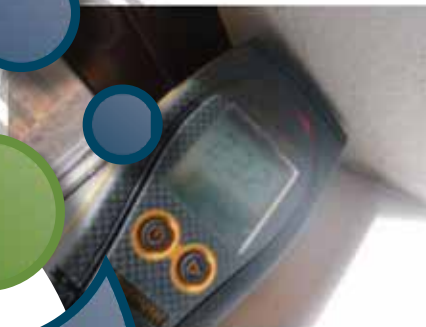
**DINING ROOM [East Side]
[MS-11]**

Water damage was observed on window sill.

This condition may indicate a moisture problem that could lead to microbial growth.

Moisture Content: **Wet**

Suspected source(s)/
cause(s): Water intrusion
at window

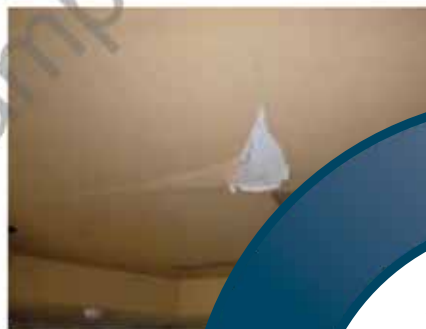
Water damage was observed in this area.

This condition may indicate a moisture intrusion problem. Moisture can lead to microbial growth.

Moisture Content: **Dry**

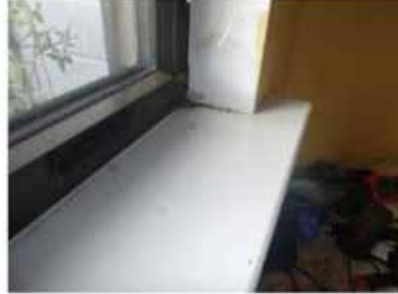
Water damage was observed on window sill.

This condition may indicate a moisture problem that could lead to microbial growth.

Moisture Content: **Dry**

Suspected source(s)/
cause(s): Window leak

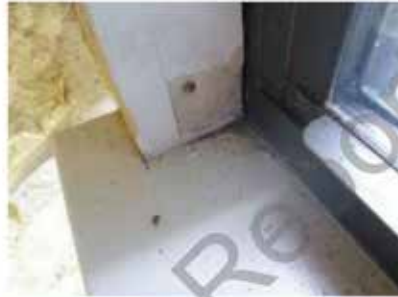
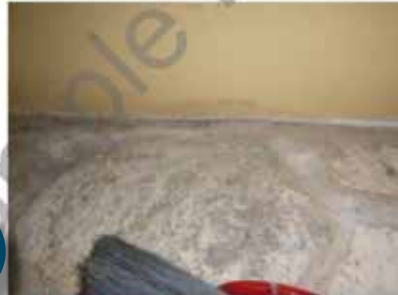
**LIVING ROOM [West Side]
[MS-15]**

Mold-like growth was observed in this area.

Client approved recommended surface sample, referenced as DE4.
(Independent laboratory analysis attached)

Wall below window

Moisture Content: **Wet**

Suspected source(s)/
cause(s): Window leak

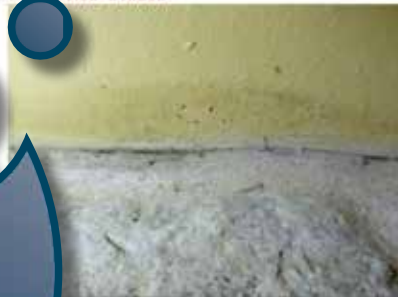
LIVING ROOM [West Side] [MS-16]

Wall materials tested in this area indicated high moisture content.

This condition is an indicator of a water intrusion issue.

Moisture Content: **Wet**

Suspected source(s)/ cause(s): Window leak

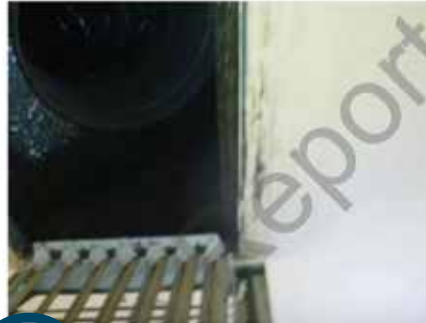
GUEST BEDROOM [MS-19]

Water damage or staining was observed on the ceiling.

Moisture Content: Dry

Suspected source(s)/ cause(s): Condensation

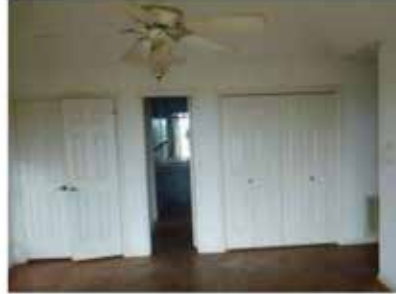
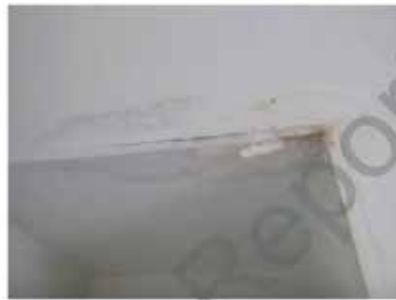
Water damage was observed in this area.

This condition may indicate a moisture intrusion problem. Moisture can lead to microbial growth.

Moisture Content: Dry

Suspected source(s)/ cause(s): Roof leaks

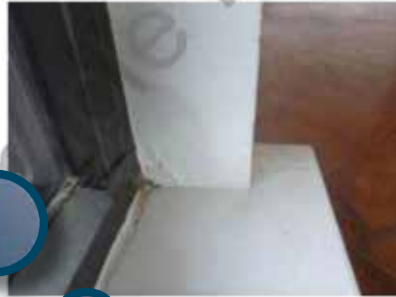
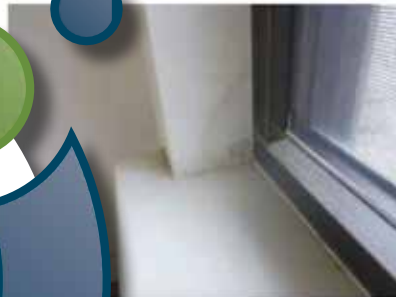
Water damage was observed on window sill.

This condition may indicate a moisture problem that could lead to microbial growth.

Moisture Content: Dry

Suspected source(s)/ cause(s): Condensation

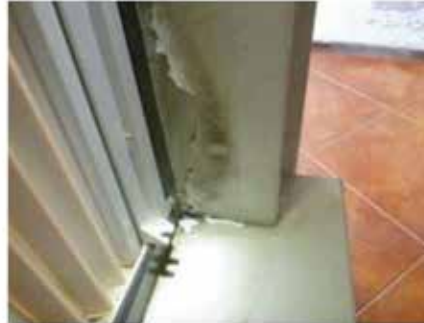
Mold-like growth was observed in this area.

Client approved recommended surface sample, referenced as, DE6.
(Independent laboratory analysis attached)

Moisture Content: Dry

Suspected source(s)/ cause(s): Leak at window

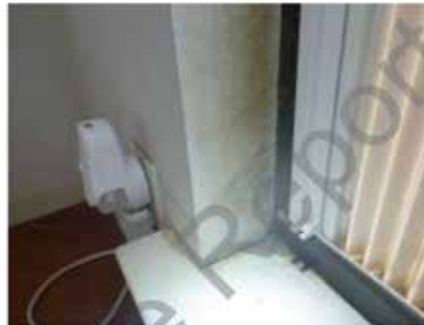
MASTER BEDROOM
[South Side] [MS-23]

Window sill tested for moisture indicated elevated moisture content.

This condition may be an indicator of a moisture problem, which may be due to deteriorated exterior window caulking or brick mortar. Moisture can lead to microbial growth.

Moisture Content: Suspect

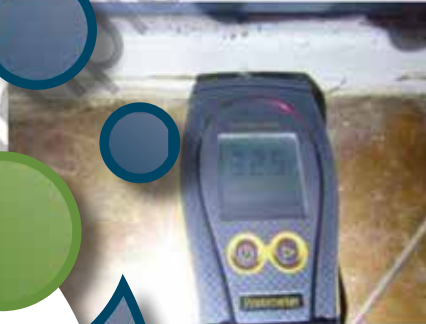
MASTER BATHROOM
[West Side] [MS-28]

Baseboard moisture
ture

Moisture Content: **Wet**

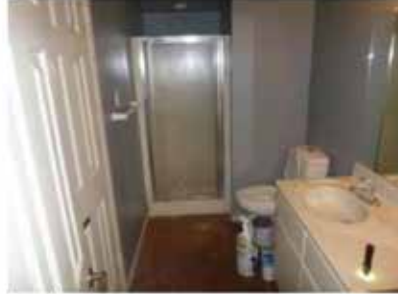
Baseboards

This condition may indicate a moisture intrusion problem. Moisture can lead to microbial growth.

Moisture Content: Dry

Suspected source(s)/ cause(s): Possible leak at shower/toilet

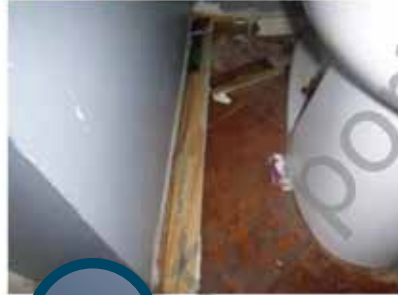
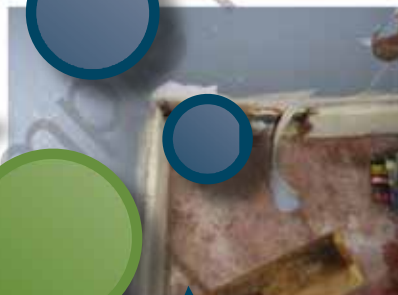
GUEST BATHROOM
[North Side] [MS-33]

Mold

Moisture Content: Dry

Suspected source(s)/ cause(s): Possible leak at shower/toilet

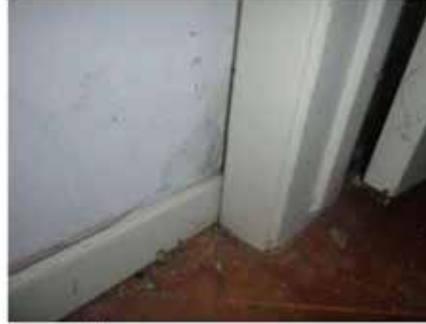
ENTRY/ENTRY CLOSET
[North Side] [MS-39]

Water damage was observed.

Moisture Content: **Dry**

Consider consulting with a licensed contractor to evaluate and repair.

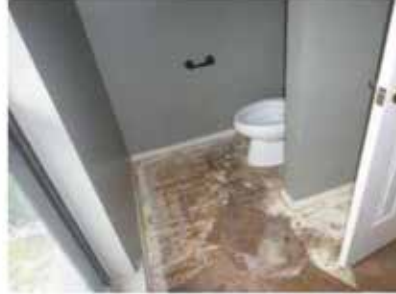
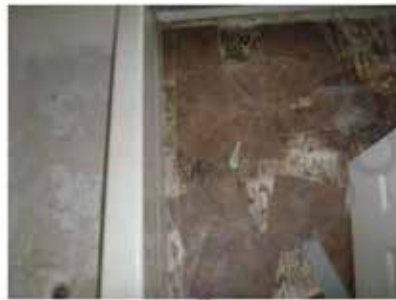
This condition is an indicator of a past or present water/moisture problem. Moisture on/under floors can lead to microbial growth.

Moisture Content: **Dry**

Humidity - this area: 92%
Humidity - Outdoor: 96%

Suspected source(s)/ cause(s): Leak at tub

* Humidity level for this area is above the ASHRAE recommended level for habitable spaces. Preferable level is between 30% and 60%.

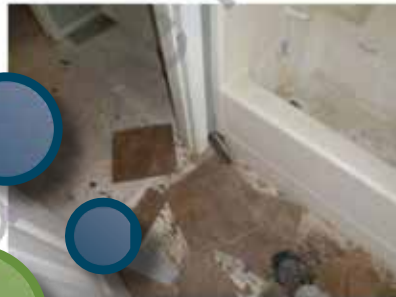
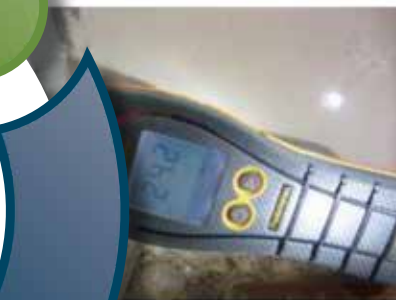
**2ND FLOOR BATHROOM
[West Side] [MS-45]**

Water damage and wet wall materials were observed at the base of the wall next to the bathtub/shower.

Moisture Content: **Wet**

Humidity - this area: 92%
Humidity - Outdoor: 96%

Suspected source(s)/ cause(s): Overspray at tub/shower

* Humidity level for this area is above the ASHRAE recommended level for habitable spaces. Preferable level is between 30% and 60%.

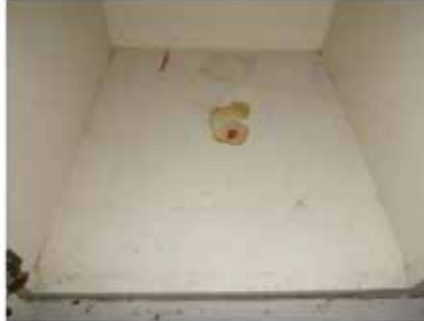
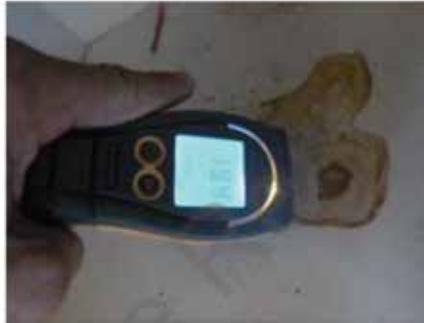
**Moisture damage was observed
below the sink.**

This condition is an indicator of a past or present water intrusion issue. Any time water has infiltrated walls or under cabinetry, hidden mold growth is possible.

Moisture Content: Suspect

Suspected source(s)/
cause(s): Leak at drain

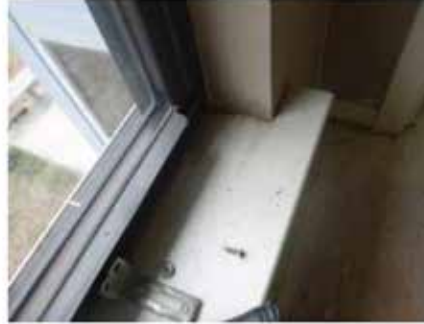
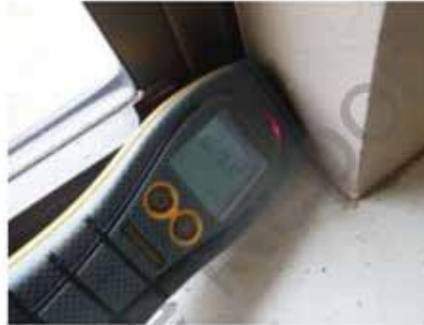
Window sill tested for moisture indicated elevated moisture content.

This condition may be an indicator of a moisture problem, which may be due to deteriorated exterior window caulking or brick mortar. Moisture can lead to microbial growth.

Moisture Content: **Wet**

Suspected source(s)/
cause(s): Condensation or
window leak

NOTICE: All wet materials should be dried out within 24-48 hours to prevent mold growth.

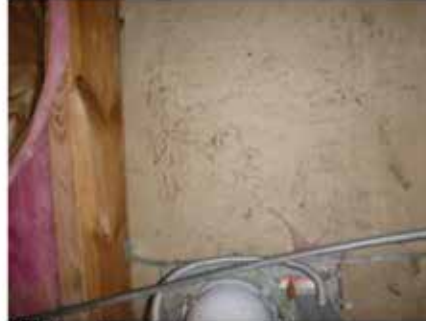
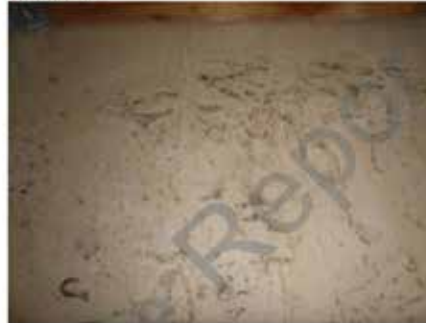
Wallboard

Mold-like growth was observed in this area.

Some mold in attic spaces may be acceptable, because it is not a controlled environment. However, mold growth in an attic may be an indicator of or may confirm a mold and/or moisture issue.

Moisture Content: Not Measured

Area affected: ~6 SF

Suspected source(s)/ cause(s): Possible HVAC overflow

Sampling suspect mold growth in an attic is sometimes recommended. Excessive mold growth may need to be remediated, especially when it is suspected to be impacting the living spaces. See the Recommendations section below.

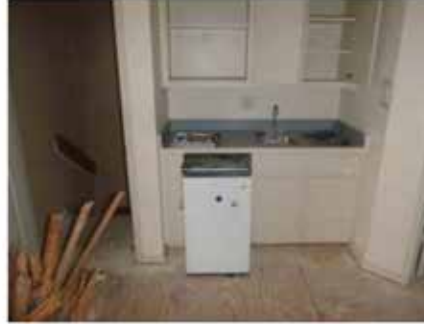
Water damage was observed in this area.

This condition may indicate a moisture intrusion problem. Moisture can lead to microbial growth.

Moisture Content: Dry

Suspected source(s)/ cause(s): Possible HVAC overflow

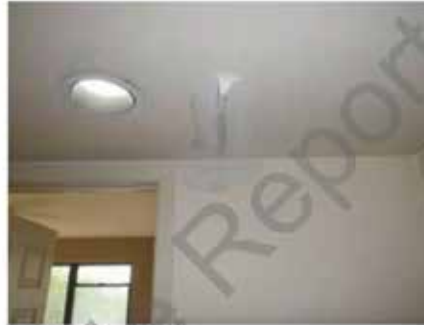
ATTIC [MS-50]

Staining was observed in this area.

This condition may indicate a moisture intrusion problem. Moisture can lead to microbial growth.

Moisture Content: Dry

Suspected source(s)/ cause(s): Condensation

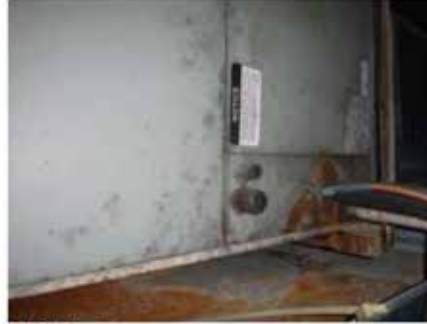
HVAC unit

Mold-like growth was observed in this area.

Moisture Content: Not Measured

Suspected source(s)/ cause(s): Condensation

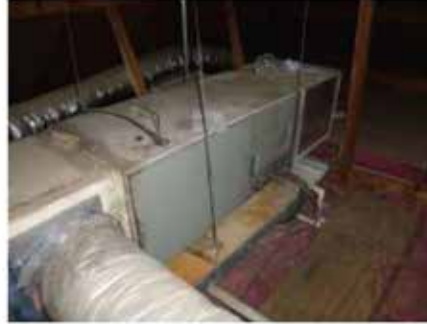
ATTIC / HVAC [PM-4]

The HVAC air handler appears to be in poor condition.

Evidence of excess moisture/condensation below the system.

Rusty drain pan

This issue was noted for preventative maintenance purposes. Consider consulting a licensed contractor for evaluation and correction or repair.

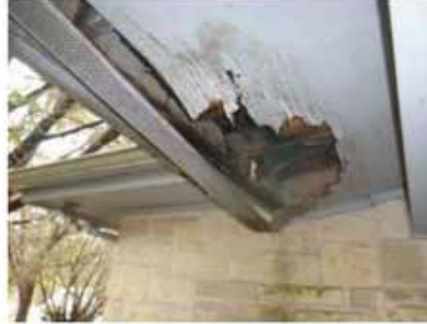
ROOF [North Side] [PM-6]

Damaged or improper roof penetrations were observed.

Plants/trees are coming into contact with the roof.

Plants/trees excrete enzymes that can deteriorate building materials. In addition, they can trap water against the structure. This can create an environment conducive to microbial growth.

Consider consulting a licensed professional for evaluation and repair.

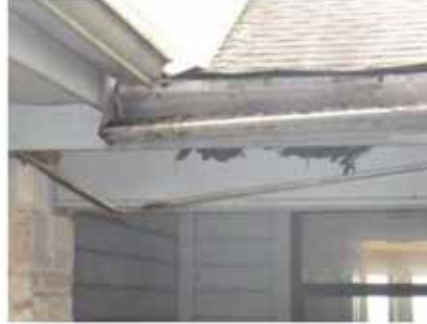
EXTERIOR [PM-10]

Damage was observed in the gutters and/or downspouts.

This condition can result in leakage. Leakage can cause water intrusions.

Splitting/bowing, water damaged and/or deteriorated siding materials were observed.

This condition can allow water to infiltrate the interior of the structure. It can also indicate present/past moisture intrusion.

Consider consulting a licensed contractor to repair or replace the damaged gutters/downspouts.

This issue was noted for preventative maintenance purposes. Consider contacting a licensed contractor to assess the siding issue(s).

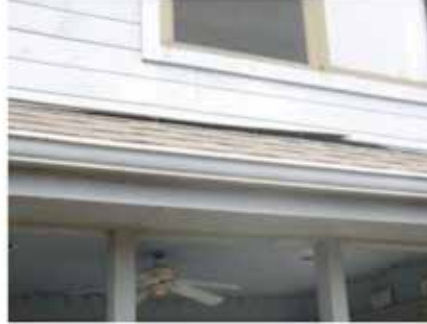
Damaged, missing, or improperly installed flashing was observed.

Consider consulting a licensed professional for evaluation and repair.
