Limited Asbestos Survey Report

1. 1st and 2nd Floors – Central rooms of the North wing
(Areas impacted by water intrusion event)

- 2.1.1 Construction Type – Slab on grade, brick veneer
- 2.1.2 Building Type – School

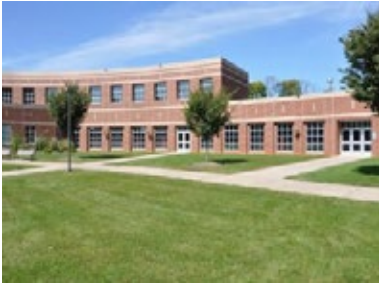
Front view of building. Faces West
